## TRANSDUCER DAMAGE FROM USING A SEMI-OCCLUSIVE DRESSING

REPEATED CLEANING OF GEL  
FROM TRANSDUCER  
MAY RESULT IN  
TRANSDUCER DAMAGE

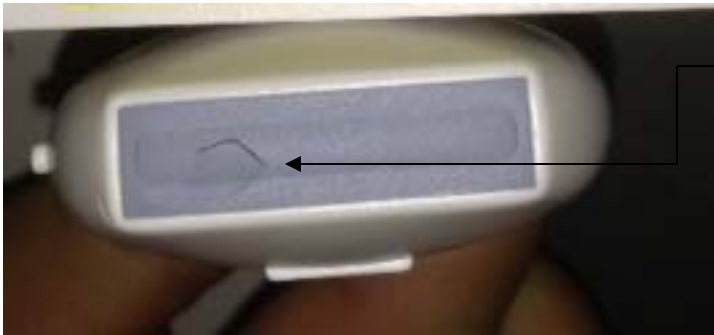
This crack in the transducer was caused by using a semi-occlusive dressing as a probe cover

These photographs were supplied by Anesthesiologists who experienced transducer damage as the result of their use of semi-occlusive dressings as probe covers. This damage might have been prevented with the use of Safersonic Probe Covers as Safersonic Probe Covers are approved as a probe cover and our adhesive does not cause delamination of the transducer head.

In addition to the delamination issue, another reason to avoid using semi-occlusive dressings is that the porosity of the semi-occlusive dressings can allow micro-organisms on the transducer to come out through the dressing. Safersonic Probe Covers are approved as a probe cover to protect patient and equipment.

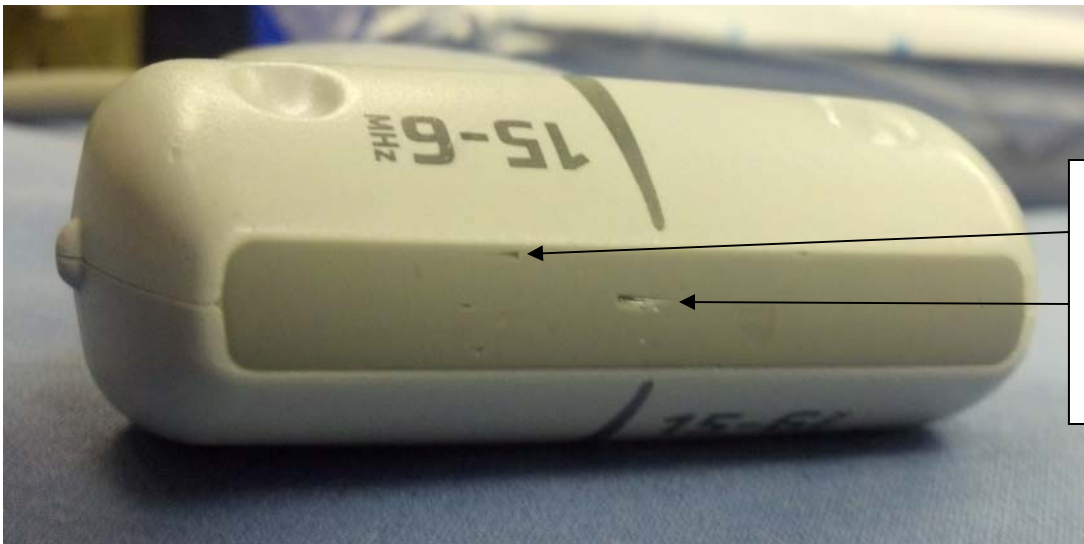
The cracks in the transducer was caused by using a semi-occlusive dressing as a probe cover

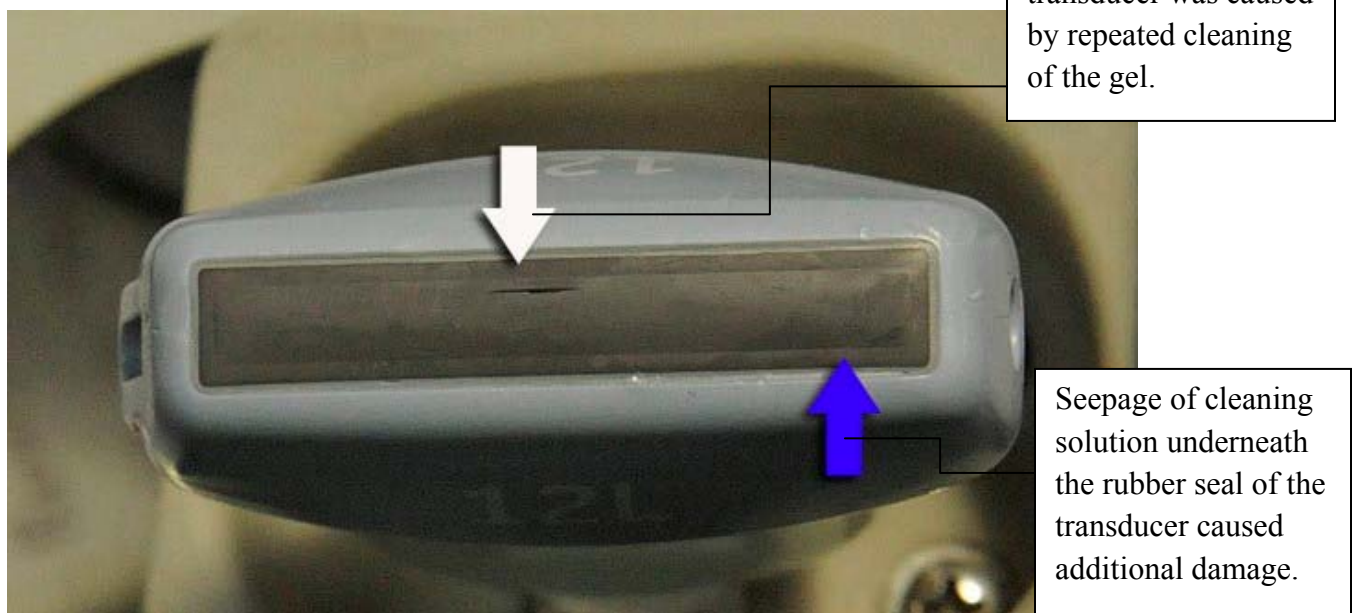
This photograph was supplied by an anesthesiologist. The transducer on his ultrasound unit needed to be replaced as a result of the required cleaning of the gel off of the transducer per standard protocol. It is possible that the wrong cleaning solutions were utilized.

However, this damage might have been prevented with the use of Safersonic Probe Covers as only Safersonic Probe Covers do not require gel under the transducer cover.
